**UNDERWATER FACILITIES  
INSPECTION AND ASSESSMENT  
AT**

**MAGNETIC SILENCING FACILITIES  
NAVAL STATION  
CHARLESTON, SOUTH CAROLINA**

**FPO-1-84(39)**

**NOVEMBER 1984**

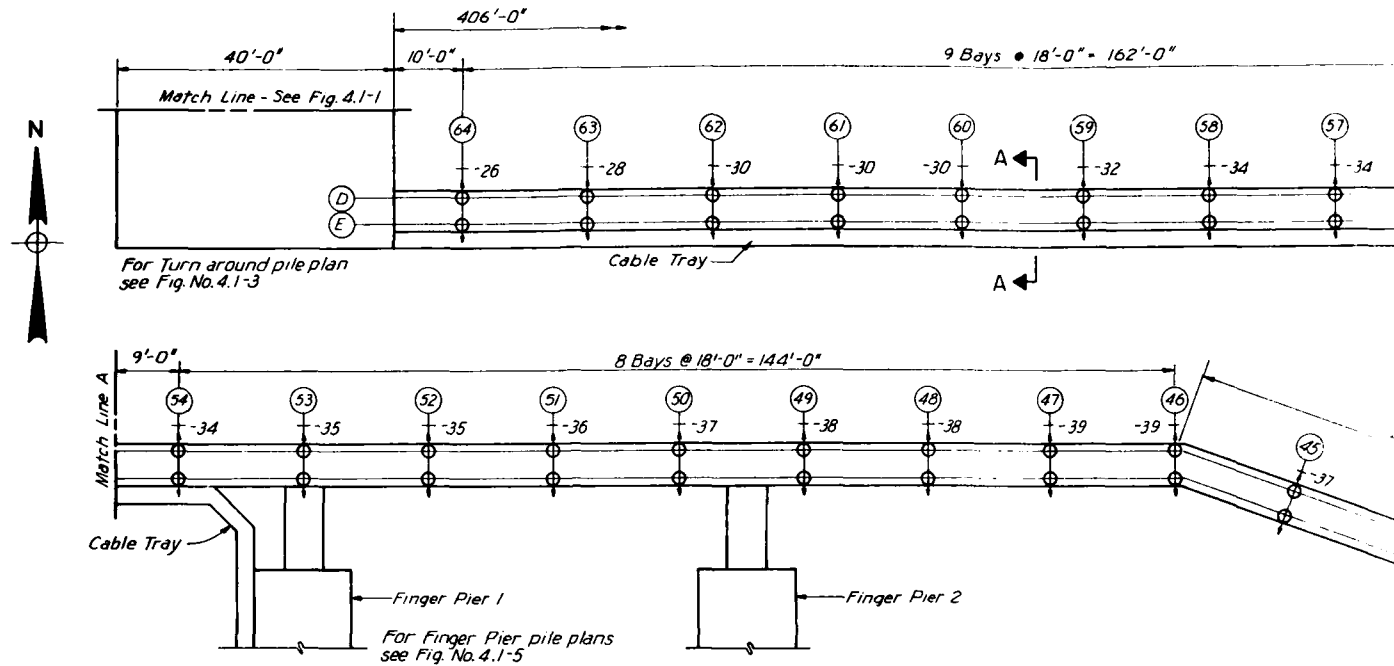
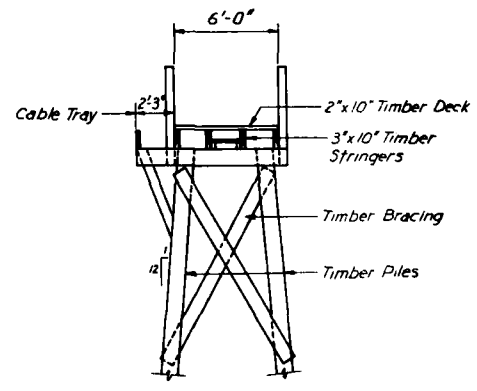
4.1-3

This drawing was developed in part from NAVFAC Drawg. Nos. 5095575, 5095581 & 5095582.  
All piles were given a Level I inspection.  
All piles were found to be in good condition.  
Piles are shown oversized for clarity.  
+ Channel bottom elevations  
Datum M.L.W. El. 0.0

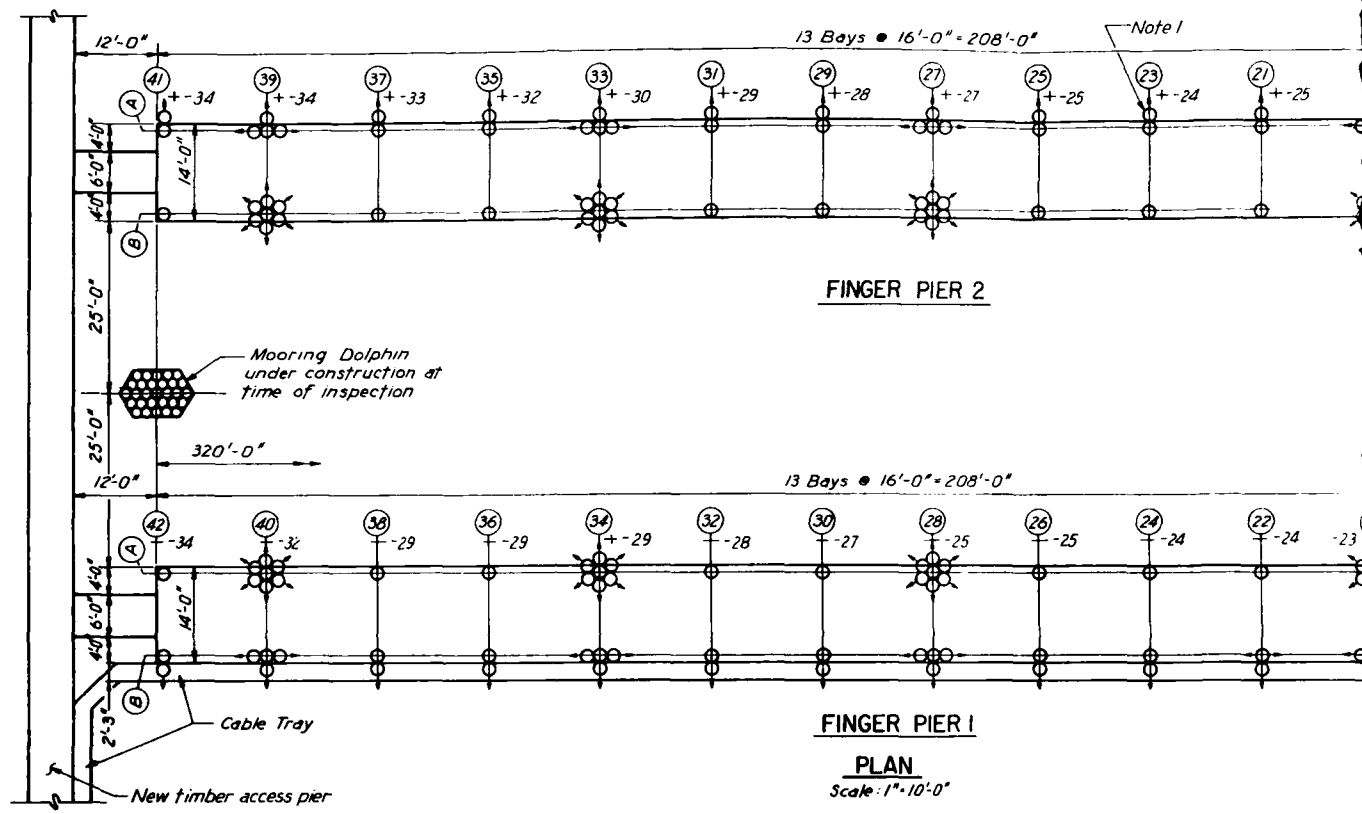
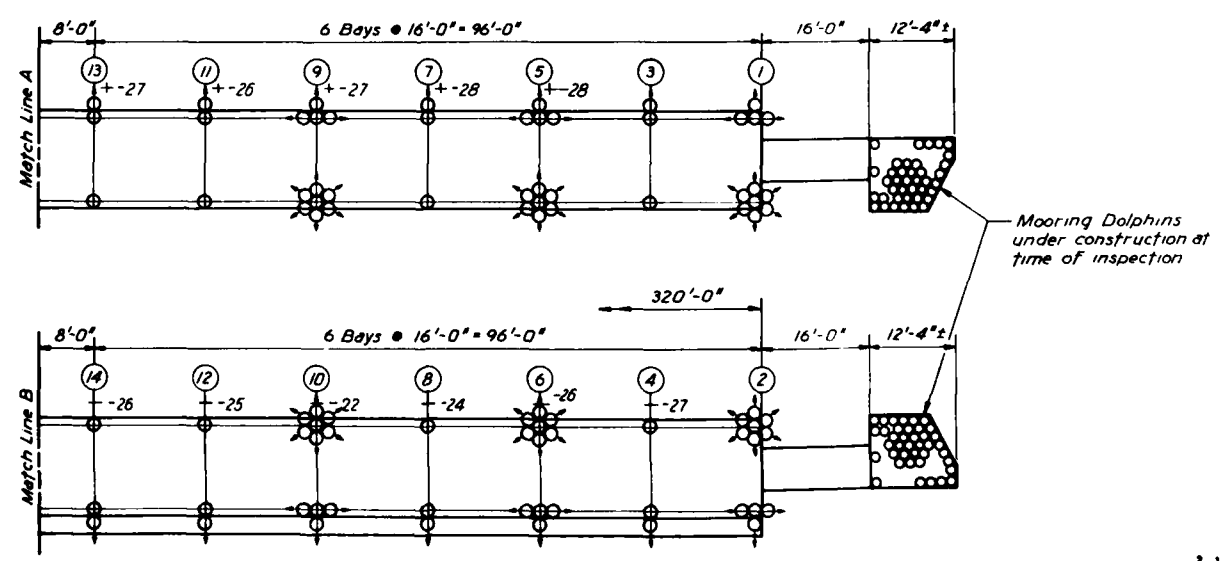
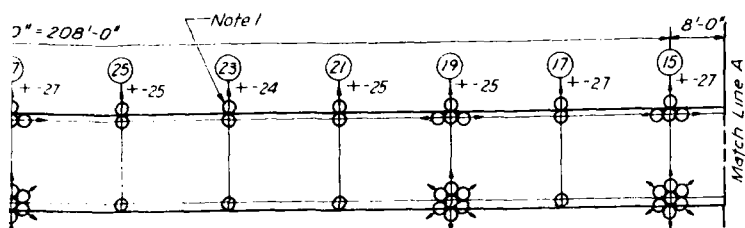
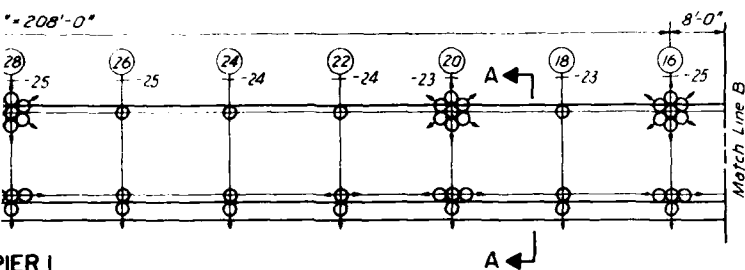
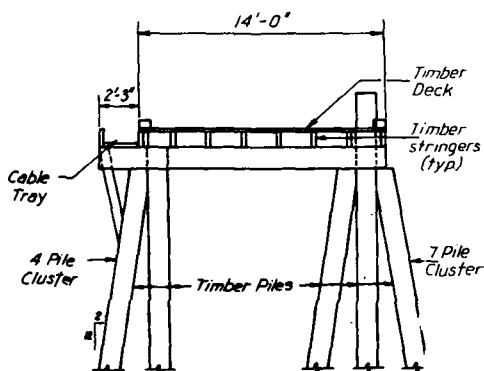
This drawing was developed in part from NAVFAC Drawg. Nos. 5095582 & 5095583. All piles were given a Level I inspection. All piles were found to be in good condition. Piles are shown oversized for clarity. + Channel bottom elevations Datum M.L.W. El. 0.0

1. North and South horizontal braces broken at water line.

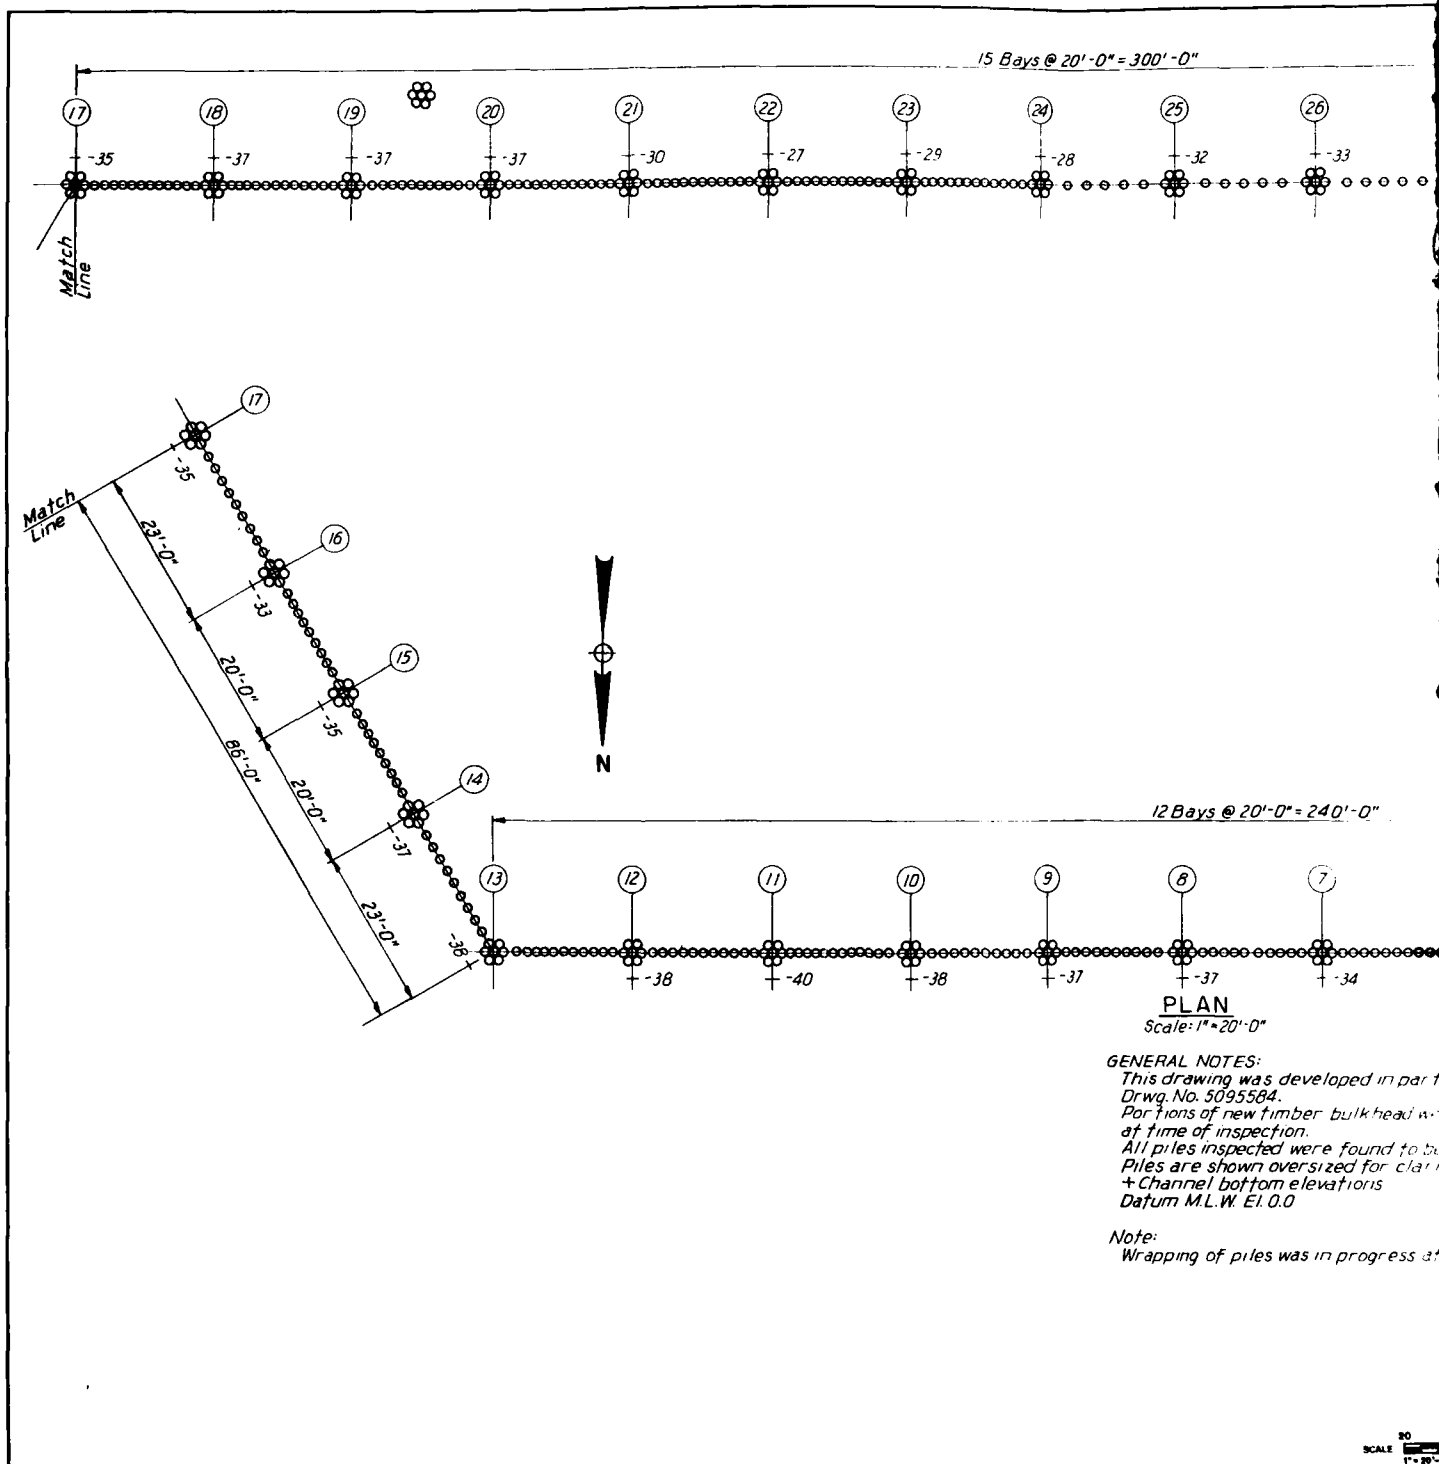
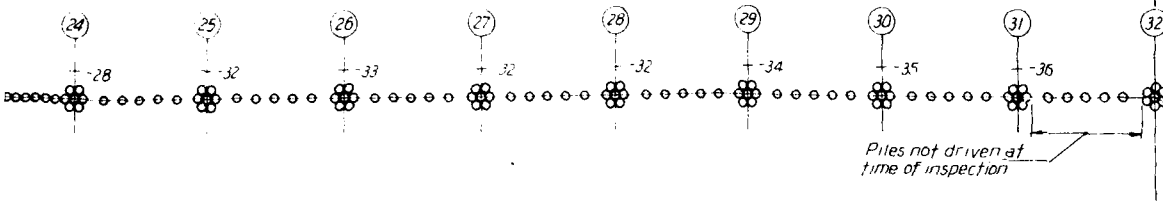
FIG. NO.  
 4.1-6

Wrapping of piles was in progress at time of inspection.

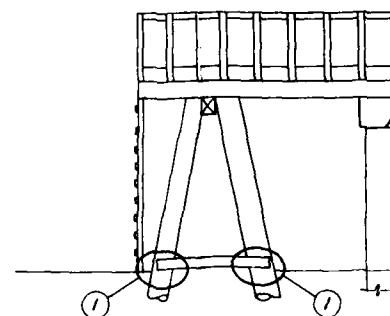
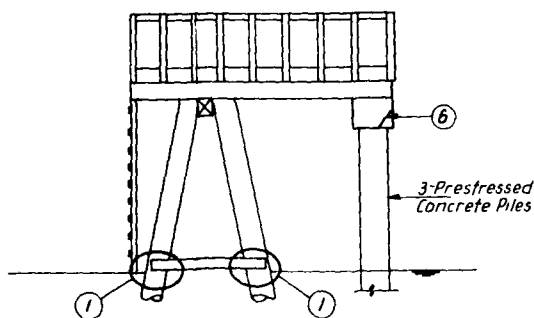
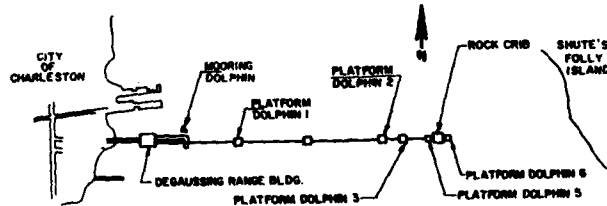
4.2-1

1. 10%-30% loss of section 4 piles for 2ft. at M.L.W.
2. 10%± loss of section of 4 piles for 2ft. at M.L.W.
3. 20%± loss of section of 4 piles for 2ft. at M.L.W.
4. 10%-25% loss of end of horizontal bracing for 1ft. at ends.
5. 10%± loss of section of piles for 2ft. at M.L.W.
6. 3 horizontal braces missing; 1 brace poor condition.
7. 10%± loss of section of piles for 2ft. at M.L.W.
8. 1 horizontal brace missing, 3 braces with 25%± loss of 1ft. at ends.
9. East face of cap cracked; bottom edge broken off.

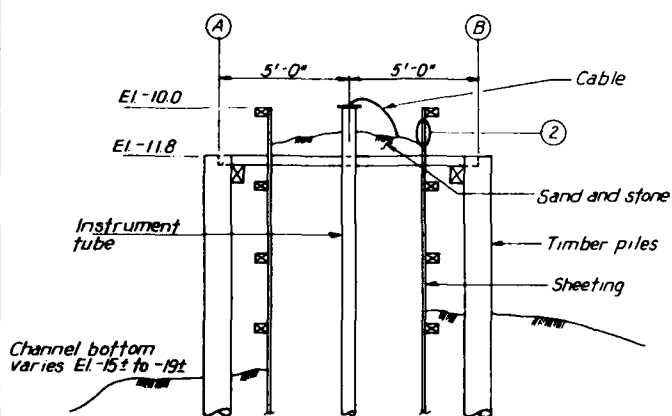
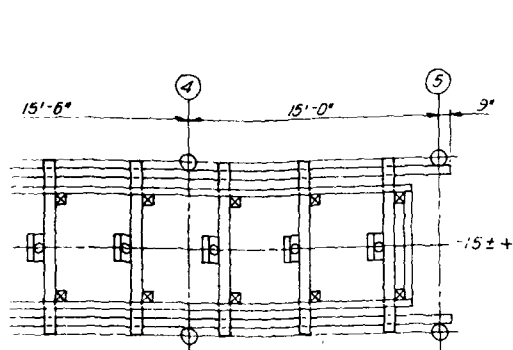
FIG. NO.  
**4.2-3**

1. All instrument tubes in good condition; vertical within  $\pm 1^\circ$ ; no tags on tubes.
2. Crib generally in good condition; minor holes in sheeting near east end of crib.
3. No undermining of crib.
4. Top timbers displaced  $6'' \pm$  at joint.

The timber crib that contains the sensor tubes of the shallow range is in fair condition. The crib was found to all be intact, and the sensor tubes were all adequately supported. All tubes were measured with an inclinometer and found to be within one degree of vertical. No identification tags were found on any of the tubes. Refer to Photograph 4.2-16 for a view of one of the sensor tubes. The timber sheeting on the east half has a number of holes and spaces between the sheets near the top of the crib, but there does not appear to be any loss of fill material at this time. Refer to Photographs 4.2-17 and 4.2-18 for views of two of the holes. The top timbers on the north side of the crib are displaced approximately 6 inches at a construction joint between the original and rebuilt portion of the crib. The fill within the crib was generally between 1 to 2 feet below the top of the crib. No evidence of undermining was found around the outside of the crib.

It is also recommended that the holes in the sheeting of the timber crib be repaired by placing grout-filled fabric bags within the crib against the defective timber.

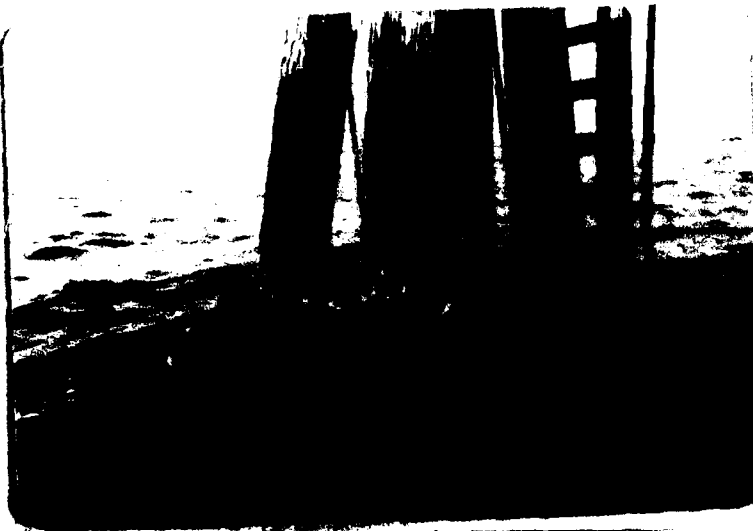
Platform Dolphins 2, 3, 4, and 5 are in fair condition. The timber piles are in good condition except at the waterline where they have experienced losses of cross-sectional area of 10 to 20 percent. The ends of the horizontal timber bracing are generally severely deteriorated from marine borer attack at each pile. Refer to Photographs 4.2-13, 4.2-14, and 4.2-15 for views of typical deterioration of the piles and bracing near the waterline.

PHOTOGRAPH 4.2-13 Platform Dolphin 3 at Waterline, MSF Downtown.

The timber piles of all platform dolphins exhibit significant deterioration in the tidal zone due to marine borer attack. The portions of the piles below the tidal zone are in good condition. Because the loads on the deteriorated portions of the piles are relatively small, the ability of the structures to perform their intended function has not been impaired at this time. If the deterioration at the waterline is not repaired in the near future, however, it can be expected that the deterioration will continue and the ability of the structures to carry normal loads will be reduced.

It is recommended that all timber piles of Platform Dolphins 1 through 5 be repaired by jacketing with concrete from approximately Mean High Water to Elevation -5. The horizontal bracing should also be replaced at the same time and be placed below the tidal zone.
